BRINKLEY RV LLC

Bedroom Slide Out Leak Repair

CSC2303

Notification Date 2-8-23

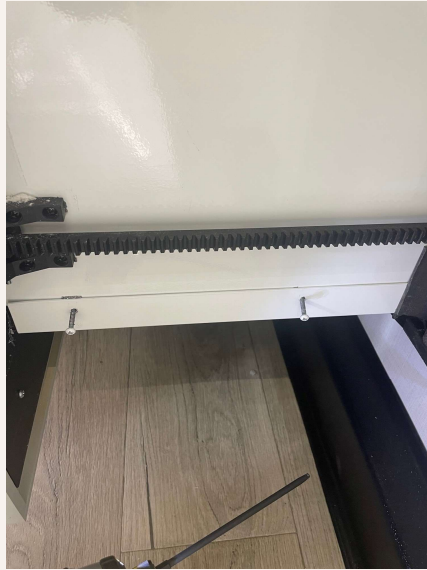
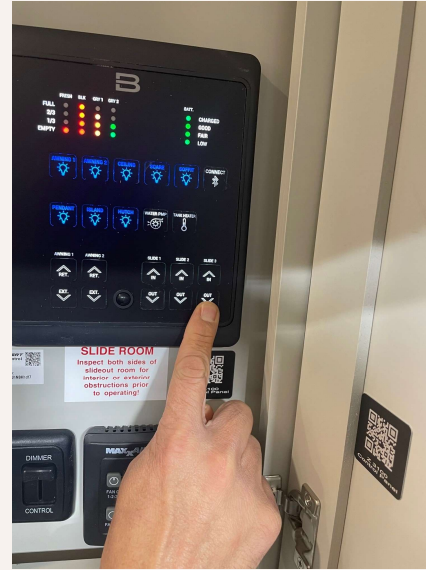
Open the closet and remove the screws that were behind the wipe seal.

Then operate the room out completely.

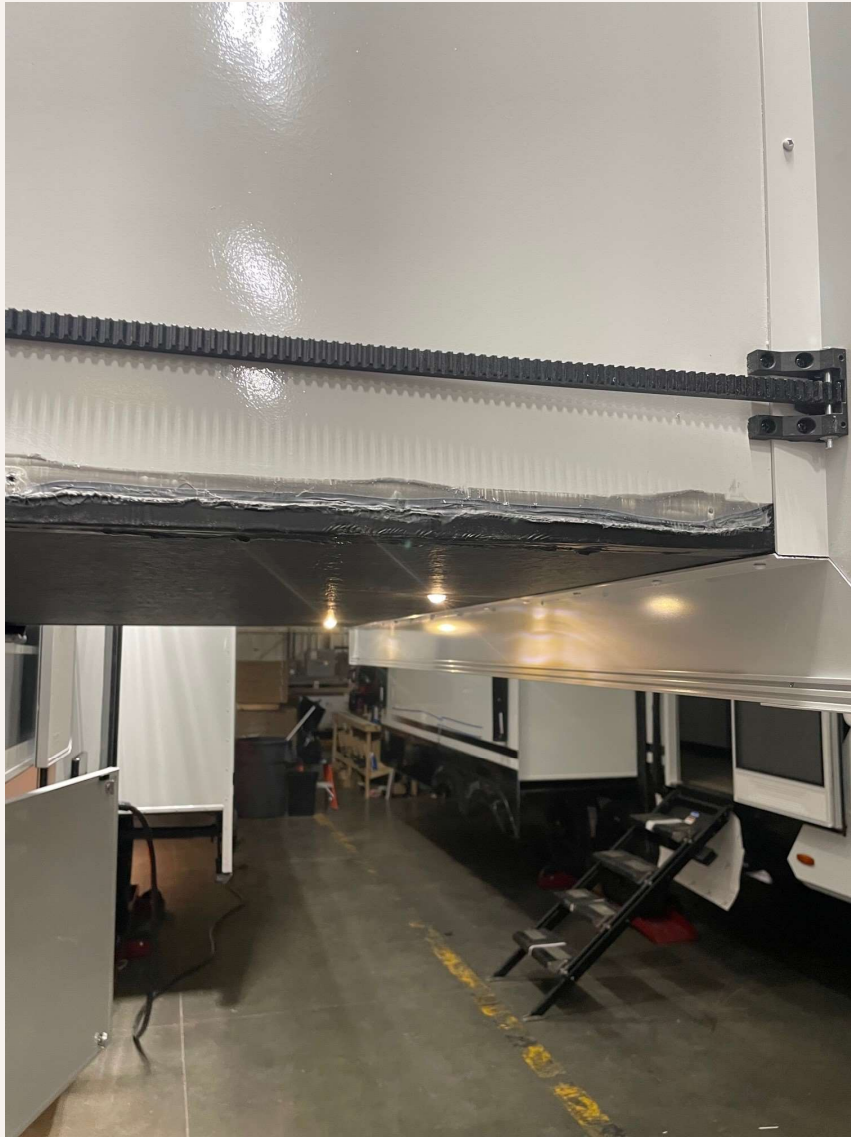
Using the blue bone and the 5in1, gently pry the rail off.
Once you get it started, you can cut through the butyl and pull the rail off completely.
